HerkEdwards.com
 20655 S. Western Ave. Suite 120
 Torrance, CA 90501

Fort Irwin Middle School
 1700 Pork Chop Hill
 Fort Irwin CA 92310

Job No. 573
 Inspection Date 3/20/2025
 Inspector Richard

Bleachers Inspection

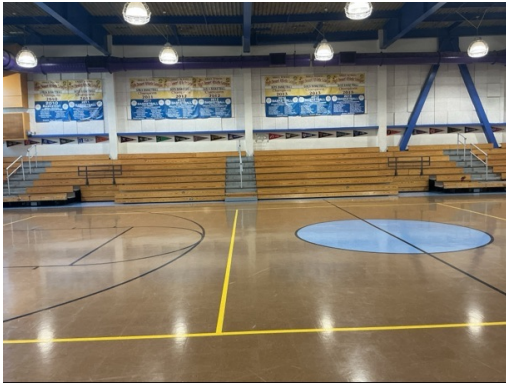
Banks 1	Tiers 7	Rise 95/8	Row Spacing 22
Bleacher Type Hussey	Seat type Wood Seatboard	Material Wood	Color Wood
Working from	Left to Right <input checked="" type="radio"/>	Right to Left <input type="radio"/>

Recommend Cleaning underneath bleachers to mitigate dust accumulation. Recommend implementing new wheels - some beginning to deteriorate. Educate on proper floor cleaning procedure.

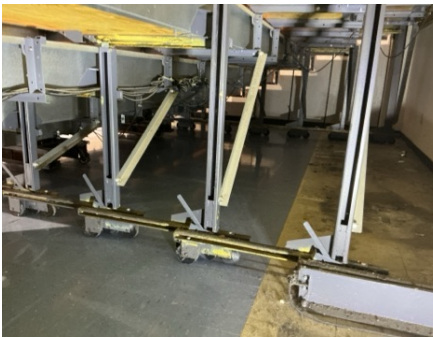
Sect 1

Frame Tier	Section 1 frames good	WO Status <input type="radio"/>
Motor 2	Section 1 have 2 motors	WO Status <input type="radio"/>
Frame 3 Tier 3	No flex rows	WO Status <input type="radio"/>
Frame	Section 2 still good	WO Status <input type="radio"/>
Frame Tier	Sec 5 have 2 motors	WO Status <input type="radio"/>

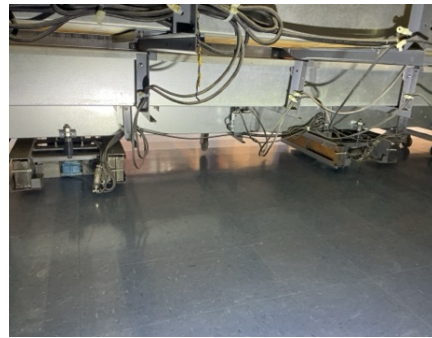
Sec 1 have 2 motors

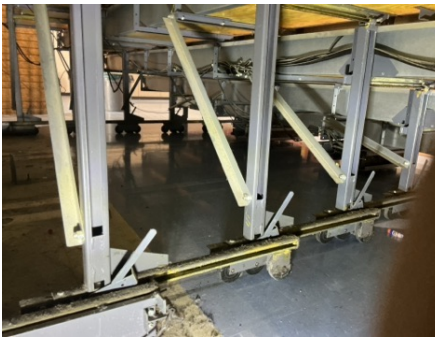
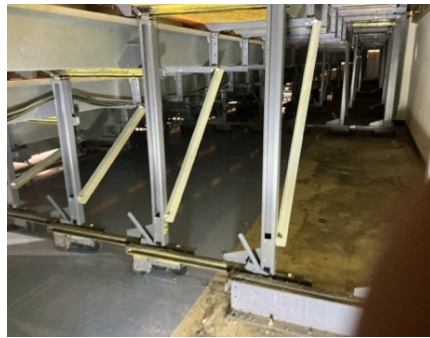
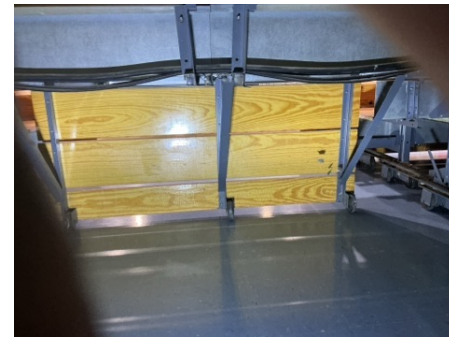
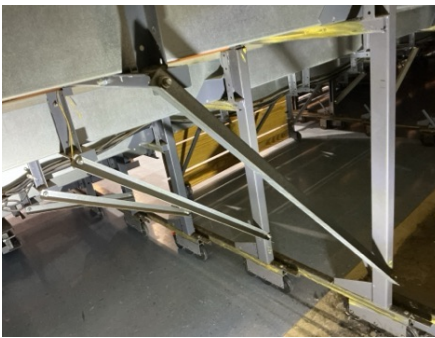
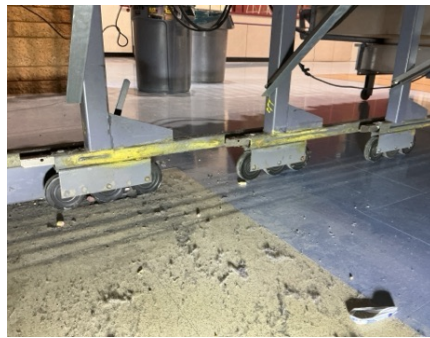
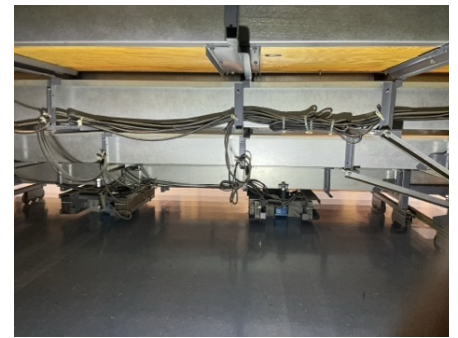
All section understructure look in good shape still	WO Status <input type="radio"/>
	Also all cable hardness still good condition	WO Status <input type="radio"/>
	Wheels and e clips are still good	WO Status <input type="radio"/>
	All bracing is good	WO Status <input type="radio"/>
		WO Status <input type="radio"/>

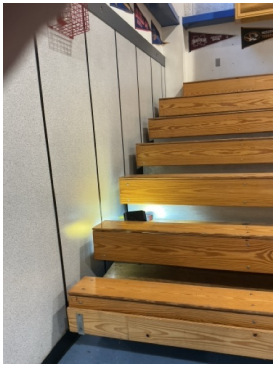
Sec 1

Section 1 of the bleacher distance away from the wall is 4 inches	WO Status <input type="radio"/>
	Recommend maintenance bleacher is not closing all the way back	WO Status <input type="radio"/>
		WO Status <input type="radio"/>
		WO Status <input type="radio"/>
		WO Status <input type="radio"/>

Bleacher is getting stuck from the wall side is not going all the way in properly

Bleacher is not closing all the way back recommend maintenance asap

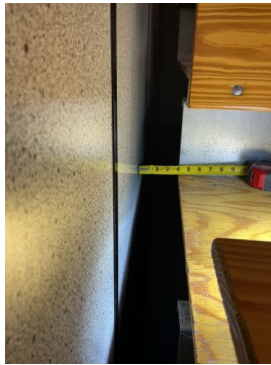
4 inches away from the wall

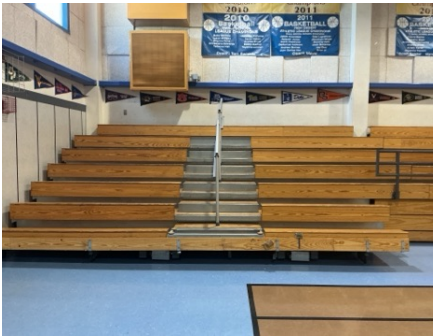
Sec 1

Section Row	All section wood bench seats good	WO Status <input type="radio"/>
Section Row		WO Status <input type="radio"/>
Section Row		WO Status <input type="radio"/>
Section Row		WO Status <input type="radio"/>
Section Row		WO Status <input type="radio"/>

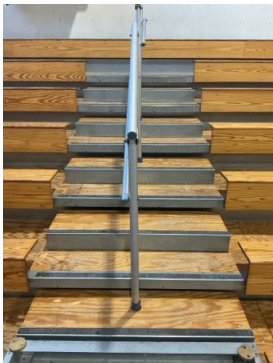
Aisle 1

Section Row	All wood steps in the aisle are still good condition	WO Status <input type="radio"/>
Section Row	Recommend bleacher maintenance	WO Status <input type="radio"/>
Section Row	All wood decking on all rows are still good and strong	WO Status <input type="radio"/>
Section Row		WO Status <input type="radio"/>
Section Row		WO Status <input type="radio"/>

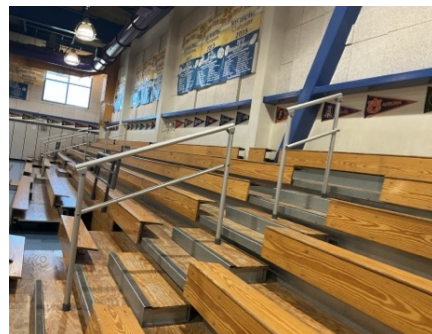
Aluminum p rails

Seating layout:	Sections	Rows	Aisles
	4	7	3
Type of aisle rails	P <input type="radio"/>	Q <input type="radio"/>	N/A <input type="radio"/>
Other Aluminum Multi Deck Span Handrails			
Access hatch location:	No		
Bleacher Length:	20 ft -20ft-20ft-18 ft 8 inch s		
Seat Count per Section:	5 / 16 /16 / 5
